**Flood Control Project Maintenance  
Levee Inspections**  
**LMA District Cover Sheet**  
**Spring 2020 Levee Inspection Results**

**Reclamation District No. 0785 Driver**

**Levee Inspection Report By Mile - Spring 2020**

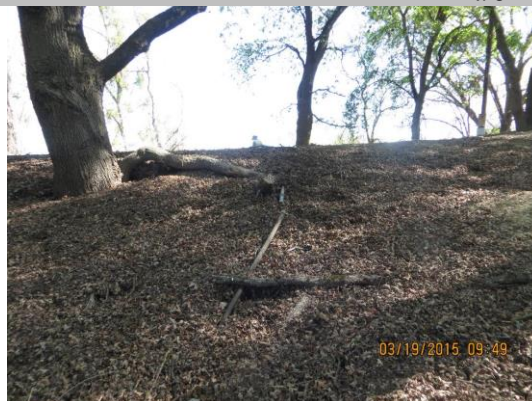
Photo 1 of 2 : UCIP\_SP\_2020\_43965\_73439.jpg

LM Start	0.00	Rating **	M	Issue No.	357	
LM End	0.00	Issue Type +	En	Location *		
Category	Supplemental			GPS Latitude/Longitude		
				Start	End	
Item	DWR UCIP Field Study			38.654407 °	38.654407 °	
				-121.605937 °	-121.605937 °	
DWR ID	22976					
Comment Code						
Inspector Comment						
DS_ID:22976						
FS_ID:43965						
EP_NO: N/A						
Repair Type: Non-Urgent						
Crossing Status: Found						
UCIP Comments: Pipe appears abandoned and should be done so properly.						
FIELD_STRUCT_DESC: 1 of 2: 12-inch steel irrigation discharge pipe through the levee, 11 feet below the crown. Slant pump on the waterside (WS) slope. Pipe crosses under highway fill and discharges into an irrigation ditch. [Additional Reference(s): DWR Levee Log, 1988].						
FS Date: 3/19/2015

Pipe visible on LS slope.

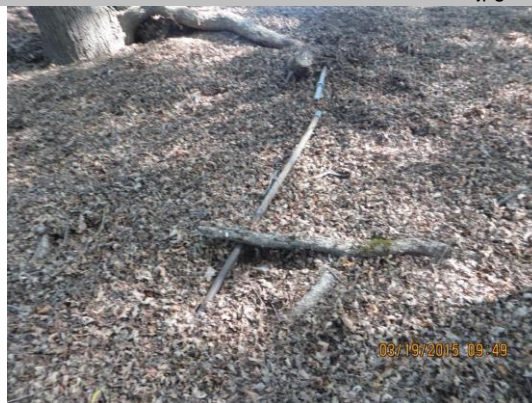
Photo 2 of 2 : UCIP\_SP\_2020\_43965\_73438.jpg

Pipe visible on LS slope.

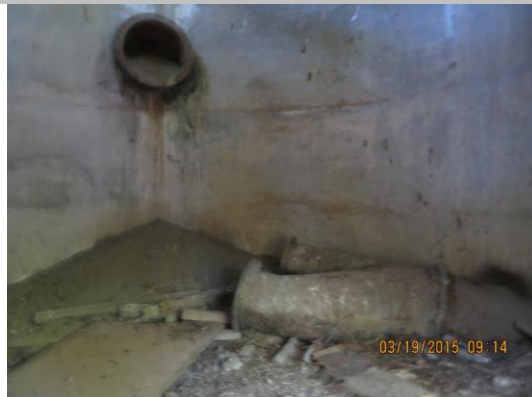
Photo 1 of 3 : UCIP\_SP\_2020\_53407\_73402.jpg

Comment Code						
Inspector Comment						
DS_ID:22974 FS_ID:53407 EP_NO: N/A Repair Type: Non-Urgent Crossing Status: Found UCIP Comments: 07/17/2018 Unable to acces pumphouse due to heavy vegetation. No integrity issue observed, therefore crossing downgraded to "Non-Urgent". Crossing is a part of DWR DMP Phase1 for internal video inspection. (O.Yakimov-DWR UCIP)07/18/2016 Same as last inspection. Pipe is silted in as visible through the LS pumphouse. (K. Fazel - UCIP)03/19/2015 Pipe appears to be abandoned and should be done so properly as it is open on the LS inside the pumphouse. Dense vegetation on both sides of the levee. (G. Wylie - FPIIB) FIELD_STRUCT_DESC: *ABANDONED* 30-inch steel pipe of an unknown purpose through the levee, 10 feet below the crown. Landside (LS) end open inside a concrete pump house on the LS shoulder. Unable to find the pipe on the waterside (WS). [Additional Reference(s): DWR Levee Log, 1988. USACE Sacramento O&M Manual 122.1, August 1955, (RM 70.05), 18-inch pipe referenced, invert elevation 33.4 feet]. FS Date: 7/17/2018 7:50:37 AM

Pipe open at base of concrete building on LS shoulder. No pump found.

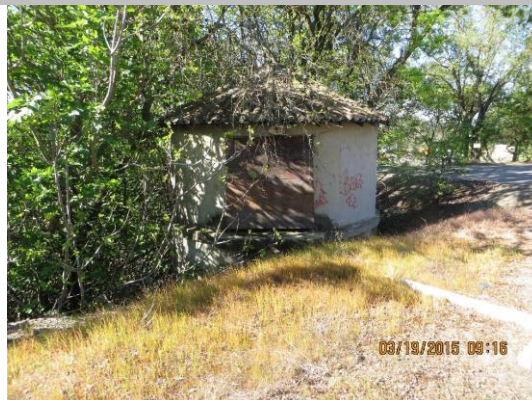
Photo 2 of 3 : UCIP\_SP\_2020\_53407\_73401.jpg

Pumphouse on LS shoulder.

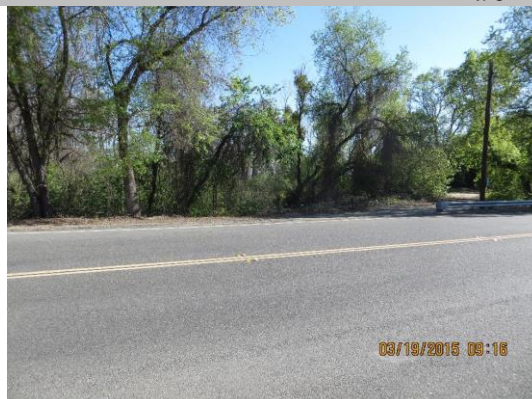
Photo 3 of 3 : UCIP\_SP\_2020\_53407\_73400.jpg

WS shoulder heavily vegetated. unable to search for pipe.

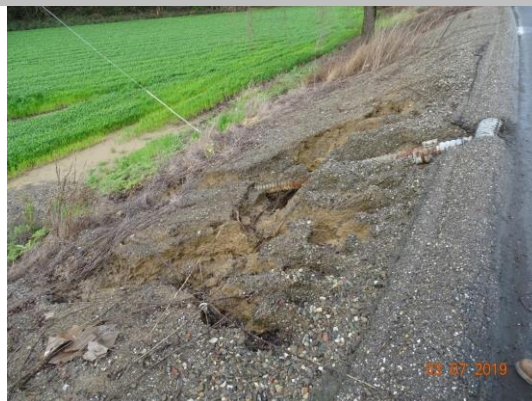
Photo 1 of 2 : SP\_2020\_RD0785\_185\_9\_20200228\_00001.jpg

LM Start	0.11	Rating **	U	Issue No.	9
LM End	0.11	Issue Type +	Ma	Location *	LS
Category	Earthen Levee			GPS Latitude/Longitude	
				Start	End
Item	Erosion / Bank Caving			38.660211 °	38.660211 °
				-121.611748 °	-121.611748 °
DWR ID	DWR_RD0785_01_f _ 2017_9				
Comment Code					
E2 : Schedule repair of erosion site prior to the next inspection.					
Inspector Comment					
Significant runoff erosion on landside slope.

View of erosion on the landside slope. Spring 2019.

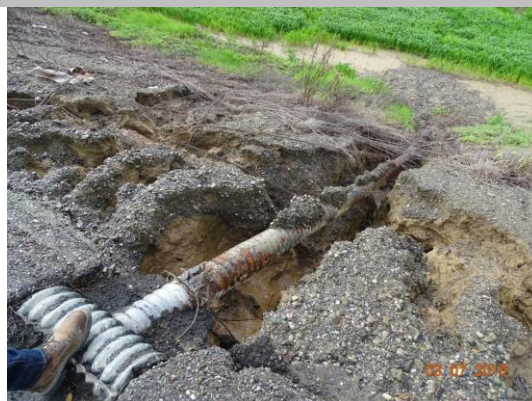
Photo 2 of 2 : SP\_2020\_RD0785\_185\_9\_20200228\_00002.jpg

View of erosion on the landside slope. Spring 2019.

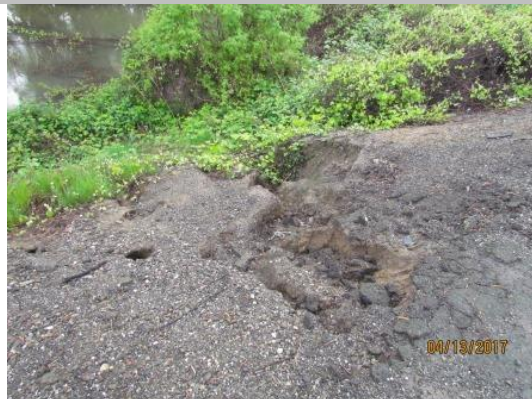
Photo 1 of 1 : SP\_2020\_RD0785\_185\_24\_20200228\_00015.jpg

LM Start	0.24	Rating **	M	Issue No.	24
LM End	0.24	Issue Type +	Ma	Location *	WS
Category	Earthen Levee			GPS Latitude/Longitude	
				Start	End
Item	Erosion / Bank Caving			38.658998 °	38.658998 °
				-121.610081 °	-121.610081 °
DWR ID	DWR_RD0785_01_s_2017_24				
Comment Code					
E2 : Schedule repair of erosion site prior to the next inspection.					
Inspector Comment					
Runnoff erosion on waterside slope.

Runoff erosion on waterside levee slope. Spring 2017.

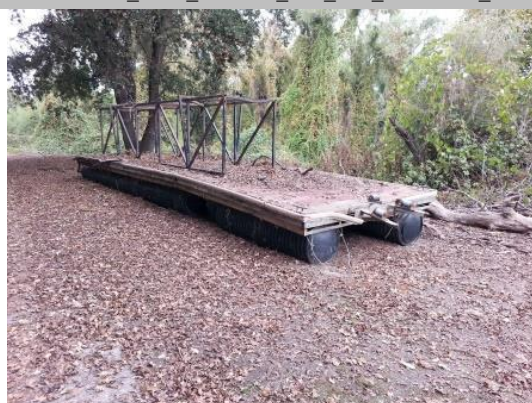
Photo 1 of 2 : SP\_2020\_RD0785\_185\_351\_20200228\_00025.jpg

View of old dock on crown/waterward side. Fall 2016.

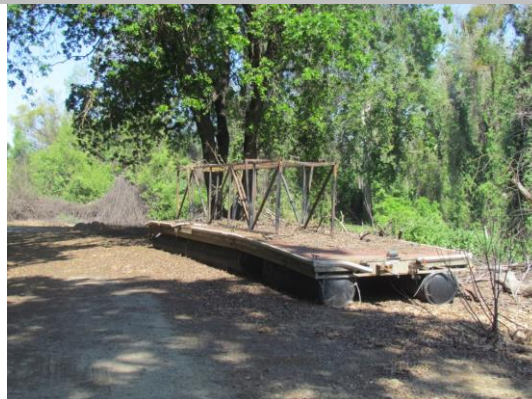
Photo 2 of 2 : SP\_2020\_RD0785\_185\_351\_20200228\_00026.jpg

View of a old dock on the waterward side of the levee looking upstream.  
Spring 2015.

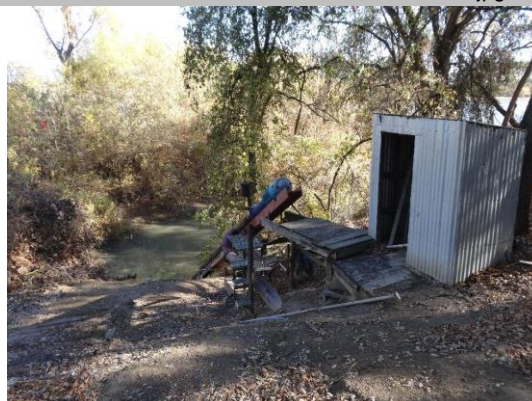
Photo 1 of 3 : UCIP\_SP\_2020\_43963\_45628.jpg

DS\_ID:22982  
 FS\_ID:43963  
 EP\_NO: N/A  
 Repair Type: Non-Urgent  
 Crossing Status: Found  
 UCIP Comments: Part of abandoned pipe also found on waterside that should be removed.No access to landside across the highway.  
 FIELD\_STRUCT\_DESC: 2 of 2: 0.75-inch steel electrical conduit through the levee, 1 foot below the crown. [Additional Reference(s): DWR Levee Log, 1988].  
 FS Date: 11/21/2013

WS view: slant pump, walkway, and electric control box in shed on levee slope.

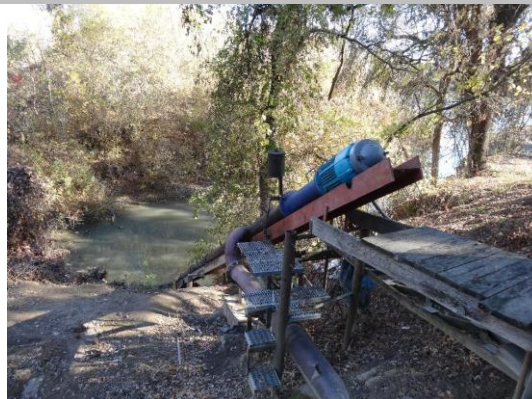
Photo 2 of 3 : UCIP\_SP\_2020\_43963\_45627.jpg

WS view: slant pump and walkway on levee slope.

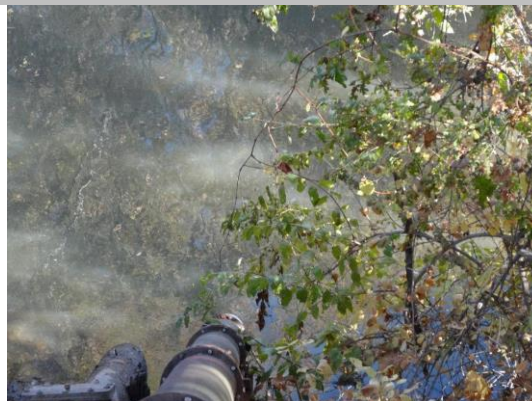
Photo 3 of 3 : UCIP\_SP\_2020\_43963\_45626.jpg

WS view: two steel pipes on levee slope. Abandoned pipe on left.

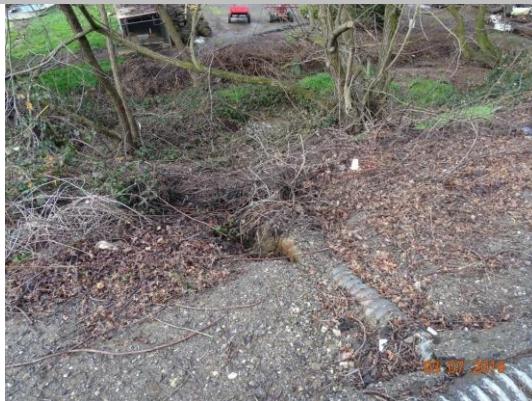
Photo 1 of 1 : SP\_2020\_RD0785\_185\_22\_20200228\_00014.jpg

LM Start	0.64	Rating **	M	Issue No.	22
LM End	0.64	Issue Type +	Ma	Location *	LS
Category	Earthen Levee			GPS Latitude/Longitude	
				Start	End
Item	Erosion / Bank Caving			38.654294 °	38.654294 °
				-121.605949 °	-121.605949 °
DWR ID	DWR_RD0785_01_s_2019_22				
Comment Code					
E2 : Schedule repair of erosion site prior to the next inspection.					
Inspector Comment					
Erosion around drainage pipe.

View of erosion on the landside slope. Spring 2019.

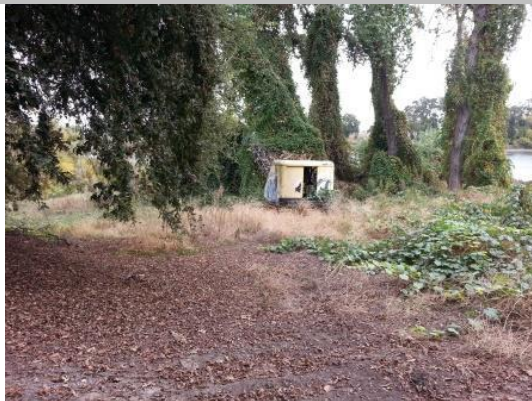
Photo 1 of 1 : SP\_2020\_RD0785\_185\_49\_20200228\_00022.jpg

LM Start	0.68	Rating **	M	Issue No.	49
LM End	0.68	Issue Type +	En	Location *	WS
Category	Earthen Levee			GPS Latitude/Longitude	
				Start	End
Item	Encroachments			38.654144 °	38.654144 °
				-121.605117 °	-121.605117 °
DWR ID	DWR_RD0785_01_f _ 2016_49				
Comment Code					
EQ : Equipment					
Inspector Comment					
Abandoned crane on waterward side.

View of an abandoned crane on waterward side of the levee. Fall 2016.

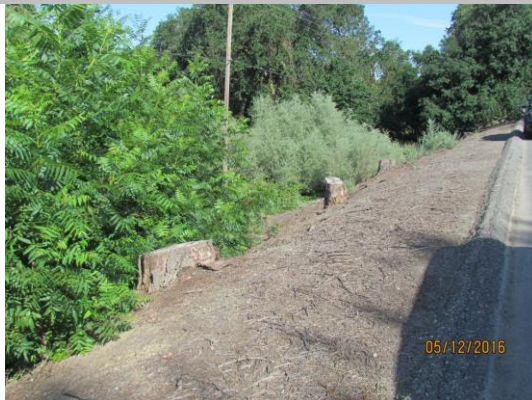
Photo 1 of 1 : SP\_2020\_RD0785\_185\_181\_20200228\_00024.jpg

LM Start	0.76	Rating **	N	Issue No.	181
LM End	0.76	Issue Type +	Ma	Location *	LS
Category	Earthen Levee			GPS Latitude/Longitude	
				Start	End
Item	Trim / Thin Trees			38.653003 °	38.653003 °
				-121.605061 °	-121.605061 °
DWR ID	DWR_RD0785_01_s_2014_181				
Comment Code					
T5 : Tree stumps.					
Inspector Comment

View of the tree stumps on the landward side of the levee looking upstream. Spring 2016.

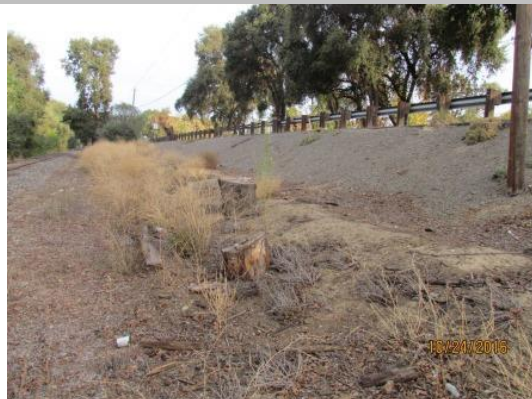
Photo 1 of 1 : SP\_2020\_RD0785\_185\_28\_20200228\_00017.jpg

Two tree stumps near levee toe on landside. Fall 2016.

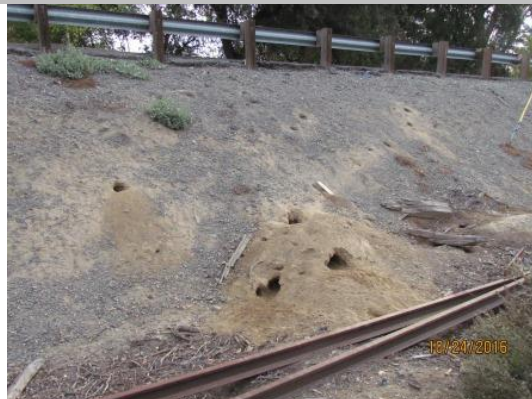
Photo 1 of 1 : SP\_2020\_RD0785\_185\_29\_20200228\_00018.jpg

LM Start	1.02	Rating **	M	Issue No.	29
LM End	1.02	Issue Type +	Ma	Location *	LS
Category	Earthen Levee			GPS Latitude/Longitude	
				Start	End
Item	Animal Control			38.649798 °	38.649798 °
				-121.602373 °	-121.602373 °
DWR ID	DWR_RD0785_01_f _ 2016_29				
Comment Code					
A3 : No rodents visible, but rodent burrows visible; need to backfill and compact or grout burrows.					
Inspector Comment					
Rodent holes on the landside slope.

View of rodent holes on LS slope. Fall 2016.

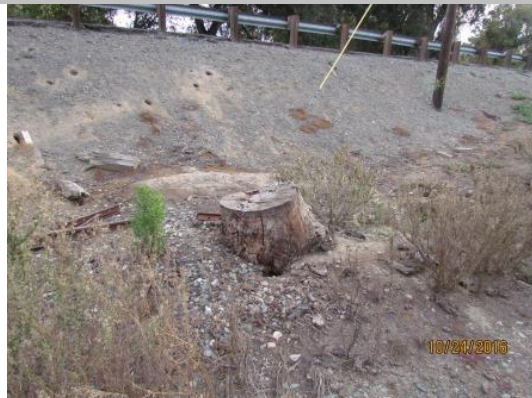
Photo 1 of 1 : SP\_2020\_RD0785\_185\_30\_20200228\_00020.jpg

LM Start	1.02	Rating **	N	Issue No.	30
LM End	1.02	Issue Type +	Ma	Location *	LS
Category	Earthen Levee			GPS Latitude/Longitude	
				Start	End
Item	Trim / Thin Trees			38.649775 °	38.649775 °
				-121.602363 °	-121.602363 °
DWR ID	DWR_RD0785_01_f_2016_30				
Comment Code					
T5 : Tree stumps.					
Inspector Comment					
Tree stump near levee toe

View of a stump near levee toe on landside. Fall 2016.

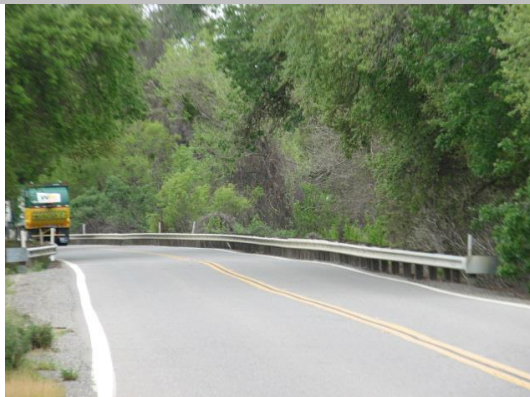
Photo 1 of 2 : SP\_2020\_RD0785\_185\_16\_20200228\_00011.jpg

Brush and other vegetation partially blocks visibility. Spring 2014

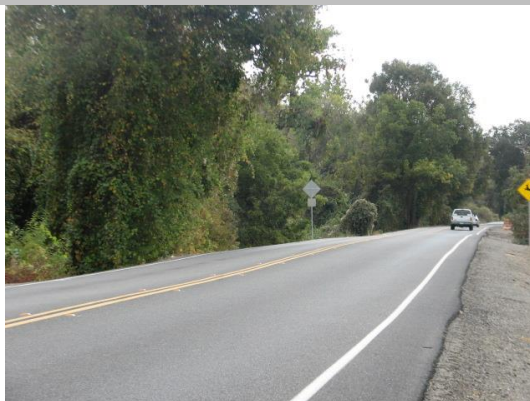
Photo 2 of 2 : SP\_2020\_RD0785\_185\_16\_20200228\_00010.jpg

Brush and other vegetation partially blocks visibility or access to the levee slope. Fall 2013

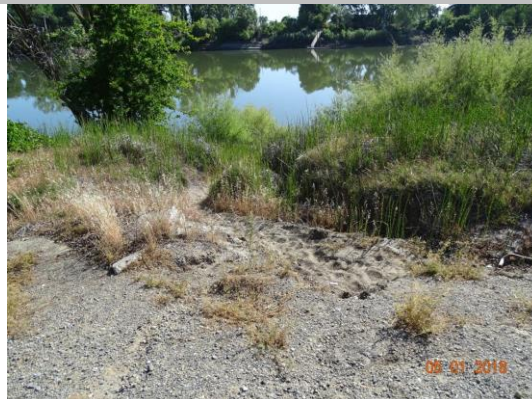
Photo 1 of 2 : SP\_2020\_RD0785\_185\_13\_20200228\_00007.jpg

LM Start	1.31	Rating **	M	Issue No.	13
LM End	1.31	Issue Type +	Ma	Location *	WS
Category	Earthen Levee			GPS Latitude/Longitude	
				Start	End
Item	Erosion / Bank Caving			38.646652 °	38.646652 °
				-121.598907 °	-121.598907 °
DWR ID	DWR_RD0785_01_s_2013_13				
Comment Code					
E2 : Schedule repair of erosion site prior to the next inspection.					
Inspector Comment					
Rills on the waterside slope.

View of runoff on the waterside slope. Spring 2018.

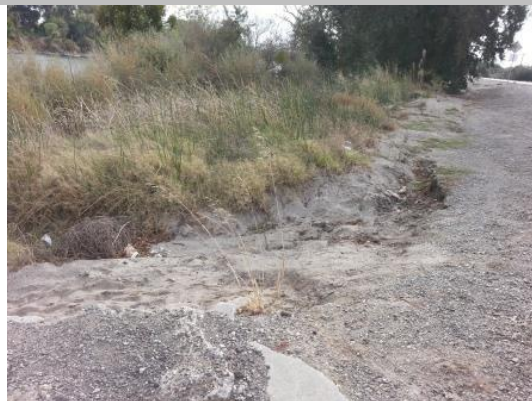
Photo 2 of 2 : SP\_2020\_RD0785\_185\_13\_20200228\_00008.jpg

View of the runoff on the waterside slope. Fall 2016.

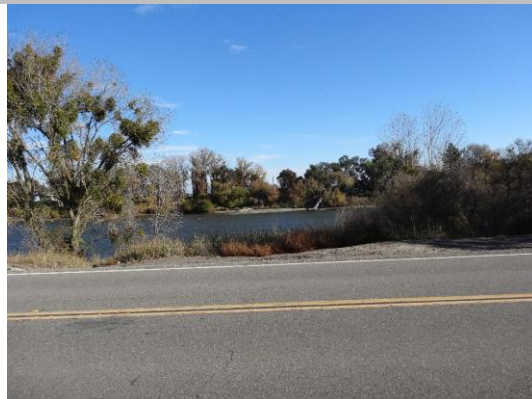
Photo 1 of 2 : UCIP\_SP\_2020\_41984\_44484.jpg

LM Start	1.31	Rating **	M	Issue No.	360
LM End	1.31	Issue Type +	En	Location *	
Category	Supplemental			GPS Latitude/Longitude	
				Start	End
Item	DWR UCIP Field Study			38.646547 °	38.646547 °
				-121.598924 °	-121.598924 °
DWR ID	22978				
Comment Code					
Inspector Comment					
DS_ID:22978 FS_ID:41984 EP_NO: N/A Repair Type: Non-Urgent Crossing Status: Found UCIP Comments: Dense vegetation on waterside. No pipe found/visible on waterside. FIELD_STRUCT_DESC: 12-inch steel pipe of an unknown purpose through the levee, 6 feet below the crown. Steel plate bolted to each end. [Additional Reference(s): DWR Levee Log, 1988]. FS Date: 11/21/2013

WS view: crown and waterside. No pipe found due to dense vegetation.

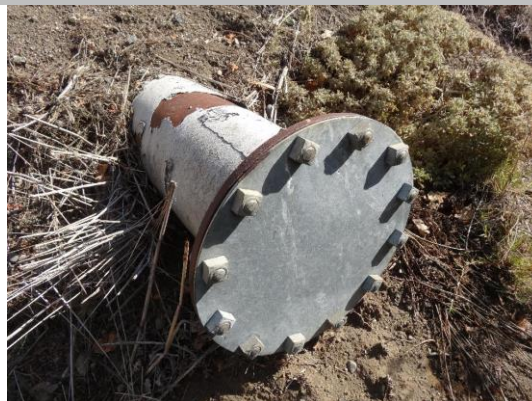
Photo 2 of 2 : UCIP\_SP\_2020\_41984\_44483.jpg

LS view: plate bolted pipe on levee slope.

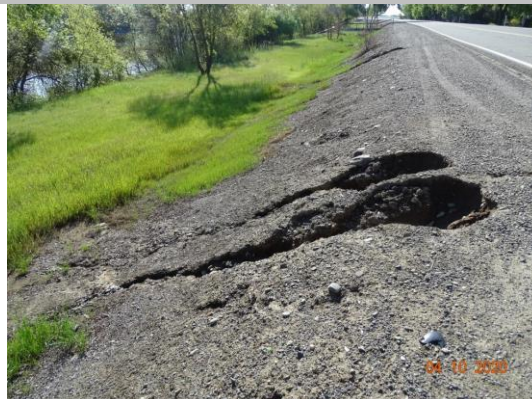
Photo 1 of 1 : SP\_2020\_RD0785\_185\_55\_20200504\_00037.jpg

LM Start	1.50	Rating **	M	Issue No.	55
LM End	1.51	Issue Type +	Ma	Location *	WS
Category	Earthen Levee			GPS Latitude/Longitude	
				Start	End
Item	Erosion / Bank Caving			38.644482 °	38.644349 °
				-121.596640 °	-121.596506 °
DWR ID	DWR_RD0785_01_f _ 2017_55				
Comment Code					
E2 : Schedule repair of erosion site prior to the next inspection.					
Inspector Comment					
Runoff on waterside slope.

View of rills on the waterside slope. Spring 2020.

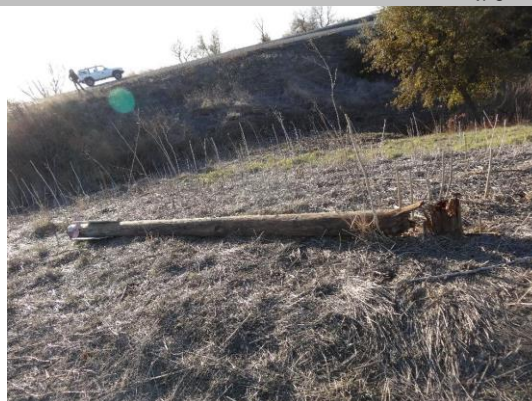
Photo 1 of 2 : UCIP\_SP\_2020\_24750\_44372.jpg

LM Start	0.01	Rating **	M	Issue No.	281	
LM End	0.01	Issue Type +	En	Location *		
Category	Supplemental			GPS Latitude/Longitude		
				Start	End	
Item	DWR UCIP Field Study			38.641086 °	38.641086 °	
				-121.620350 °	-121.620350 °	
DWR ID	22985					
Comment Code						
Inspector Comment						
DS_ID:22985 FS_ID:24750 EP_NO: 16982 Repair Type: Non-Urgent Crossing Status: Indicator Found UCIP Comments: Only a damaged indicator post found on landside across the road.Damaged indicator needs to be fixed. FIELD_STRUCT_DESC: Three 2-inch-diameter and three 1.5-inch diameter HDPE conduits containing fiber optic cables across and under the east levee (County Road 124), 67 feet below the crown. HDPE pipes were pulled through an 8-inch bore hole and backfilled with bentonite. (App. No. 16982 - Pacific Fiber Link) FS Date: 12/2/2013

LS view: damaged indicator post across the levee road.

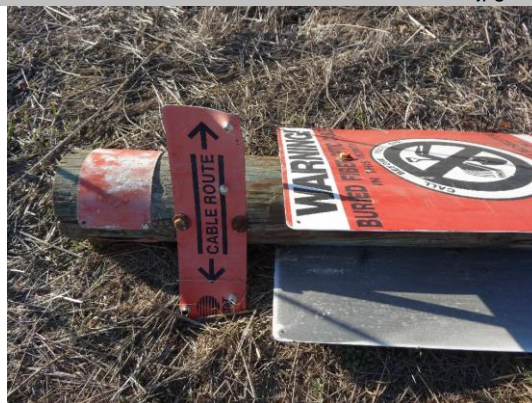
Photo 2 of 2 : UCIP\_SP\_2020\_24750\_44371.jpg

LS view: closer view of damaged indicator post.

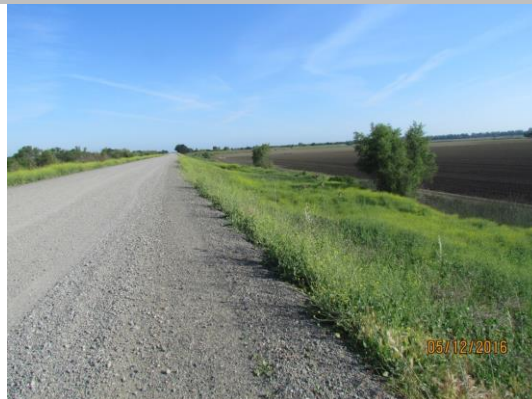
Photo 1 of 1 : SP\_2020\_RD0785\_186\_280\_20200228\_00005.jpg

LM Start	0.38	Rating **	A/W	Issue No.	280
LM End	0.38	Issue Type +	Ma	Location *	LS
Category	Earthen Levee			GPS Latitude/Longitude	
				Start	End
Item	Slope Stability			38.636265 °	38.636265 °
				-121.617422 °	-121.617422 °
DWR ID	DWR_RD0785_02_s_2015_280				
Comment Code					
S1 : Repair slope instability.					
Inspector Comment					
Seems to be a bulge at the toe of the levee. Recommend monitoring.

View of the slope stability on the landward side of the levee looking upstream. Spring 2016.

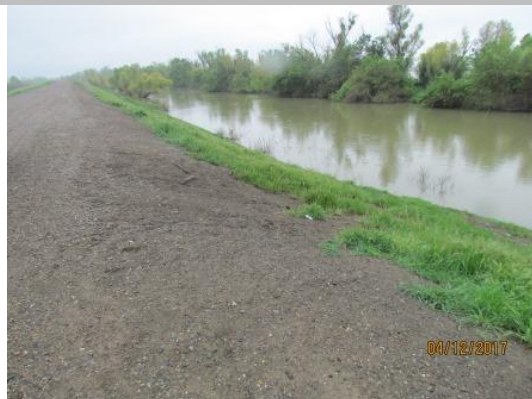
Photo 1 of 1 : SP\_2020\_RD0785\_186\_24\_20200228\_00004.jpg

LM Start	1.52	Rating **	M	Issue No.	24
LM End	1.52	Issue Type +	Ma	Location *	WS
Category	Earthen Levee			GPS Latitude/Longitude	
				Start	End
Item	Slope Stability			38.621694 °	38.621694 °
				-121.607610 °	-121.607610 °
DWR ID	DWR_RD0785_02_s_2017_24				
Comment Code					
S2 : Repair the levee slope damaged by foot traffic and prevent access where possible.					
Inspector Comment					
Footpath for environmental access site. There is a noticeable dip on the waterside slope.

View of slope stability on waterside levee slope. Spring 2017.

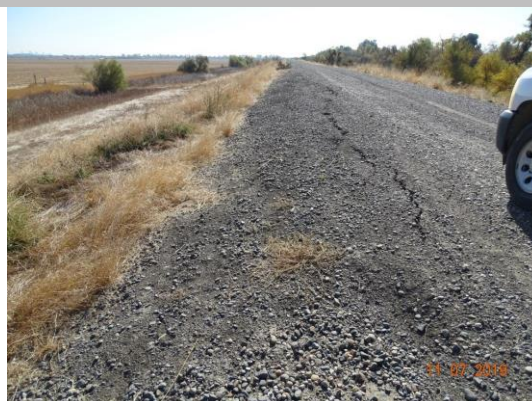
Photo 1 of 1 : SP\_2020\_RD0785\_186\_10\_20200228\_00001.jpg

LM Start	1.85	Rating **	M	Issue No.	10
LM End	1.86	Issue Type +	Ma	Location *	LS
Category	Earthen Levee			GPS Latitude/Longitude	
				Start	End
Item	Cracking			38.617562 °	38.617421 °
				-121.604431 °	-121.604321 °
DWR ID	DWR_RD0785_02_f_2019_10				
Comment Code					
CR1 : Monitor and have inspected by geotechnical engineer.					
Inspector Comment					
Appears to be a 100' longitudinal crack that shows some settlement on the landside shoulder. Recommend having the area inspected by a geotech.

View of cracking and settlement on the crown and landside shoulder.  
Fall 2019.

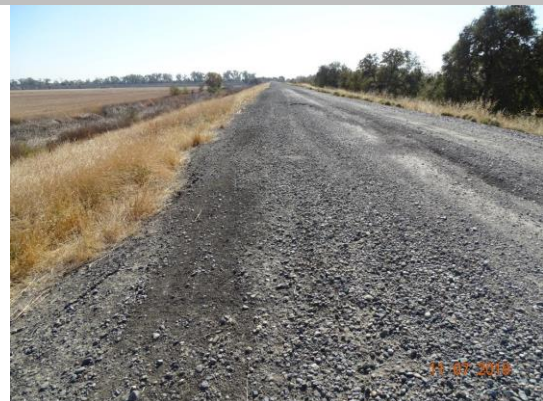
Photo 1 of 1 : SP\_2020\_RD0785\_186\_11\_20200228\_00002.jpg

View of cracking and settlement on the crown and landside shoulder.  
Fall 2019.

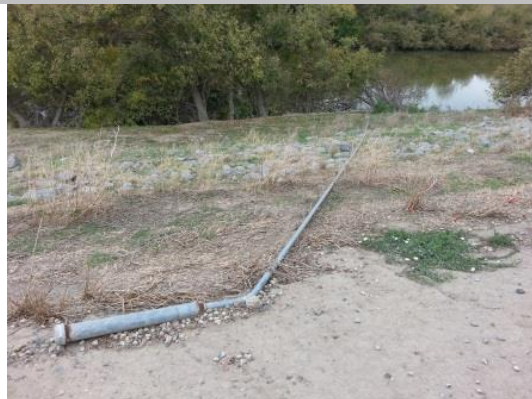
Photo 1 of 1 : SP\_2020\_RD0785\_186\_19\_20200228\_00003.jpg

View of a capped galvanized pipe on WS slope. Fall 2016.
